INSPECTION REPORT

Pre-Shipment Inspection

Report No: H-*****

| Product Description | TRAVERTINE MARBLE | | |

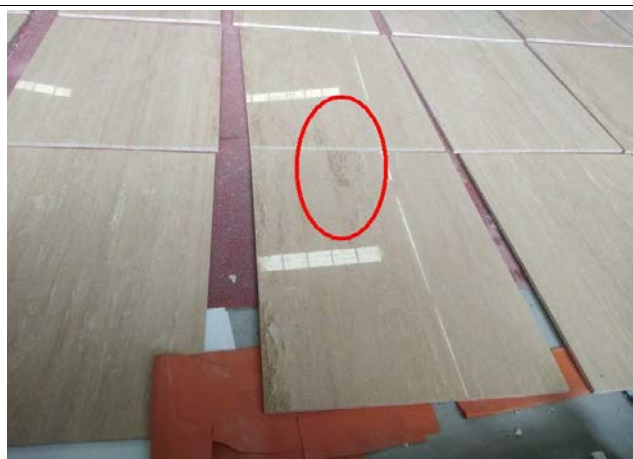
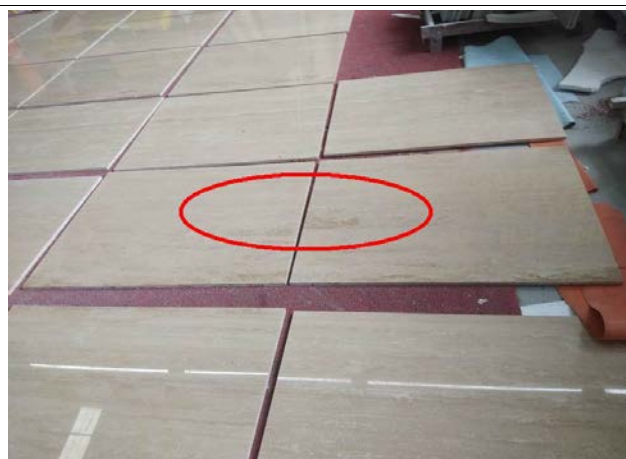
| 2.1 | For item 1200x900 (Dining and Dry kitchen), discrepancy veins flow was found between the product (23K 193) and other products. Detail as below photos. | |

SAP 2.1 Actual found

| 2.1 | For item 1200x900 (Dining and Dry kitchen), discrepancy veins flow was found between the product (23K 193) and other products. |

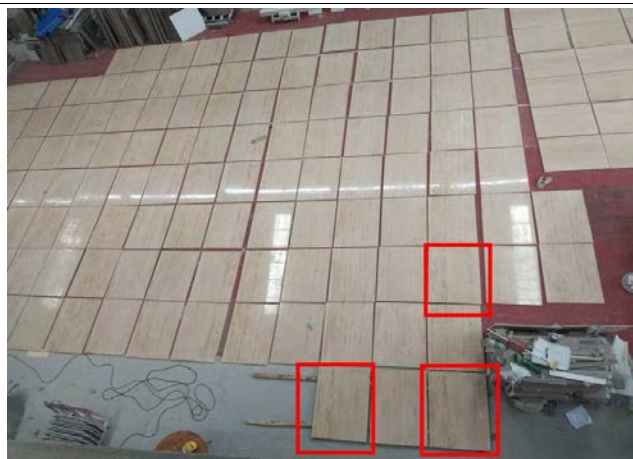
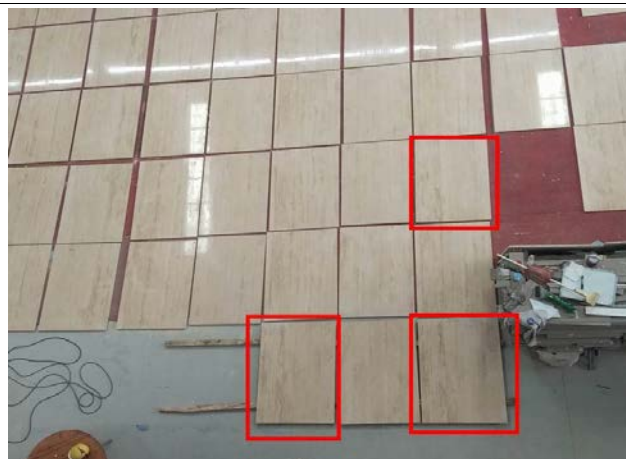
| 2.2 | For item 1200x900 (Living), discrepancy color and veins flow was found between the product (3G 016, 3E 014, 5E 036) and other products. Detail as below photos. | |

SAP 2.2 Actual found

| 2.2 | For item 1200x900 (Living), discrepancy color and veins flow was found between the product (3G 016, 3E 014, 5E 036) and other products. |

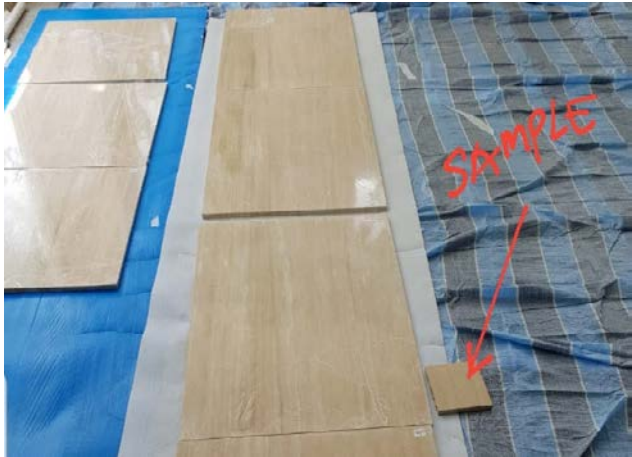
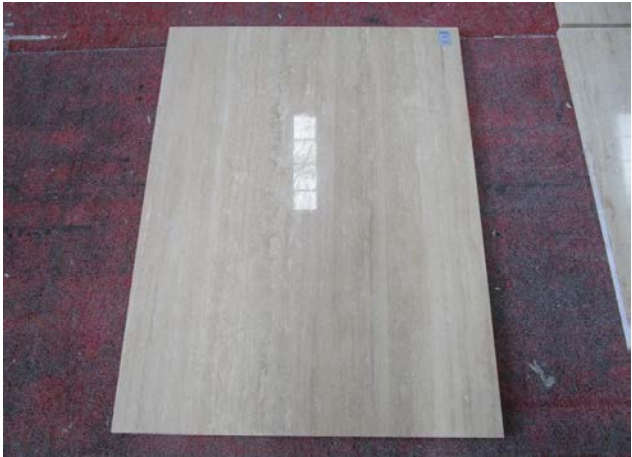
| 3.1 | For all items, color discrepancy was found between actual found and digital photo sample. Detail as below photos. | |

| SAP 3.1 Color on digital photo sample | SAP 3.1 Actual found |

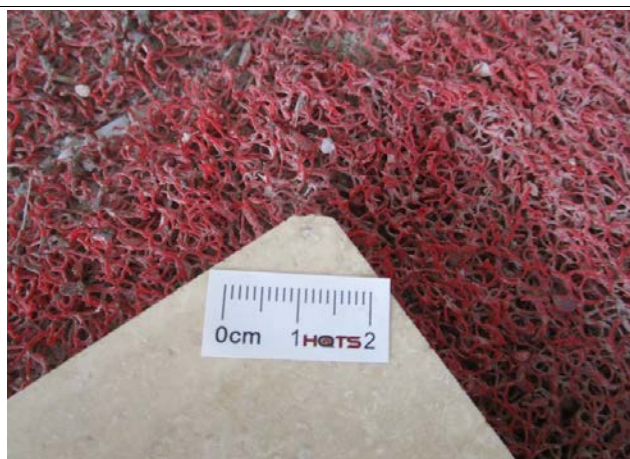
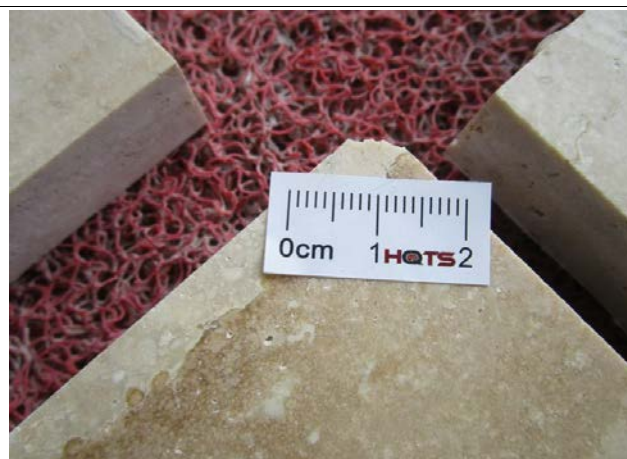
| 2.Workmanship | | | | Pending | | |
|---|--|--|--|---|---|---|
| Chip on corner(7mm) | | | | | 2 | |

Defect-item 1200x900 (Dining and Dry kitchen)-Chip on corner(7mm)-ma

| 6. Reference Note | |
|---|---|
| 6.3 | The factory repaired all the Chip defective samples during inspection. |

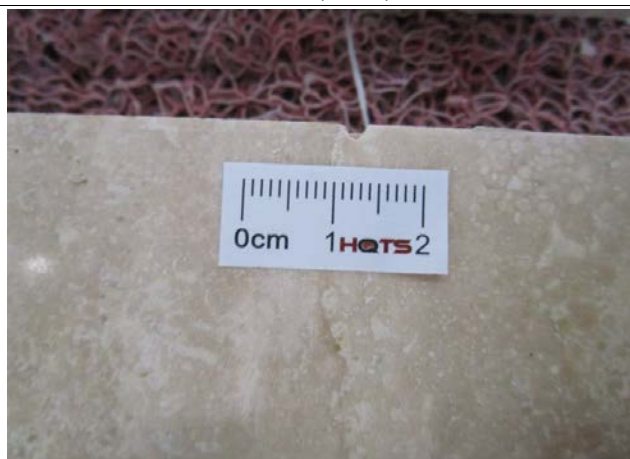
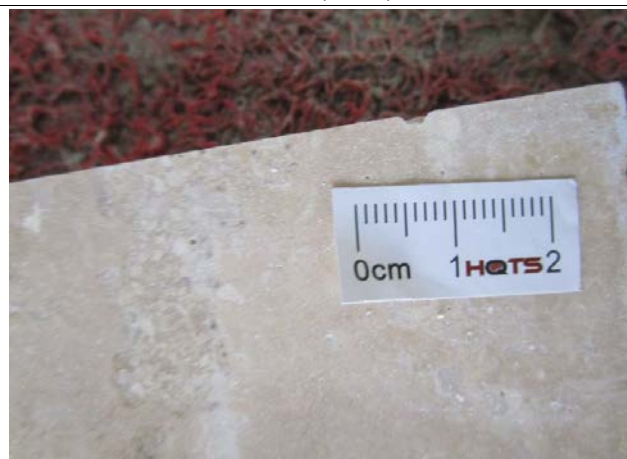
| 2.Workmanship | | | | Pending | | |
|---|--|--|--|---|---|---|
| Chip on edge(3mm-18mm) | | | | | 15 | |

Defect-item 1200x900 (Dining and Dry kitchen)-Chip on edge(3mm)-ma

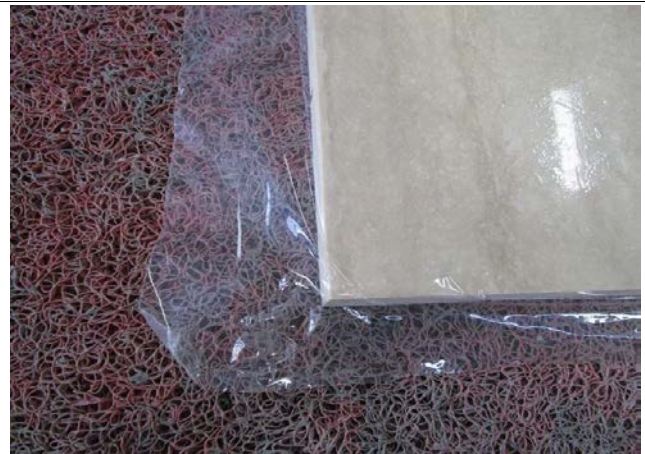
Packaging Description:
- 1 piece of product was covered with film.

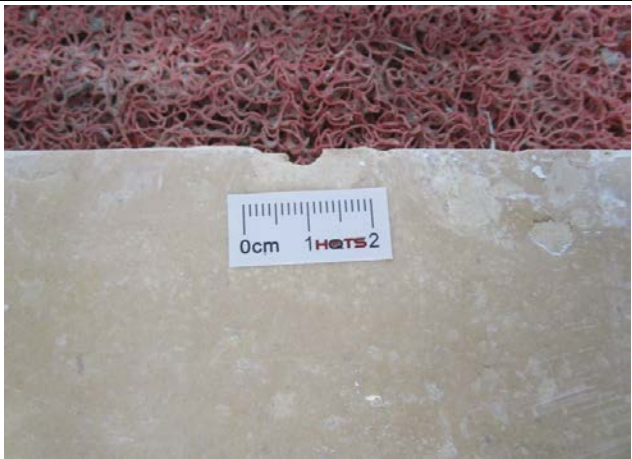
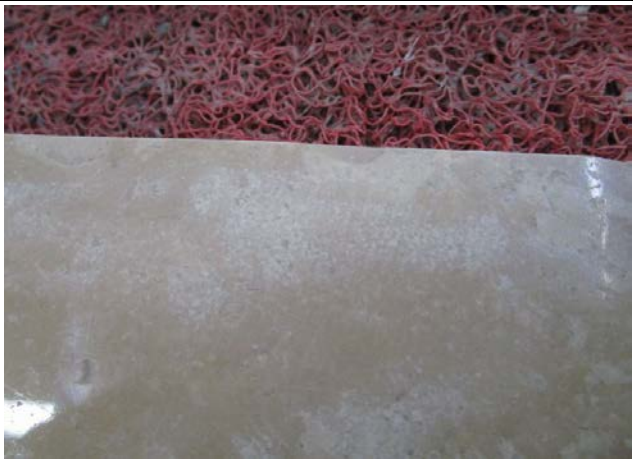
| N 6.3 Before repaired | N 6.3 After repaired |
