INSPECTION REPORT Pre-Shipment Inspection	Report No. : H-XXXXX
---	---	----------------------

INSPECTION INFORMATION			
Client	XXXXXX		
Supplier	XXXXXX		
Factory	XXXXXX		
Inspection Instruction	GWI-H-004-HQT		
P.O. No.	P21308008	Sampling Plan	ANSI/ASQC Z 1.4-Single; Normal
Item No.	902203, 900060 etc.	Inspection Level	G-II
Inspection Date	2013-11-21 to 2013-11-22	Sample Size	125 PIECES
Inspection Location	FUQING, CHINA	AQL	Critical: 0 Major:2.5 Minor:4.0
Product description	Automotive Glass

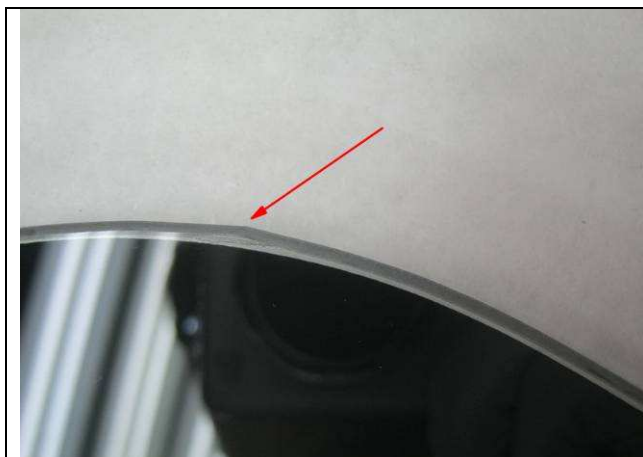
2.1	Except for item 900961, 900971, 902239 and 900203. All the inspected samples were found slight extension in the radius at one corner.
-----	---

SAP 2.1-slight extension in the radius at one corner

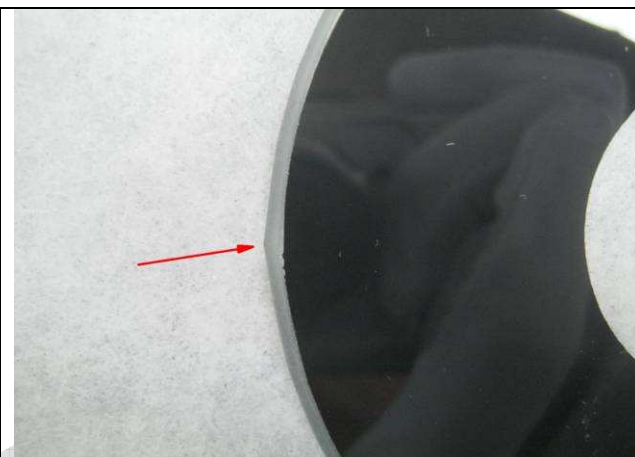
SAP 2.1-slight extension in the radius at one corner

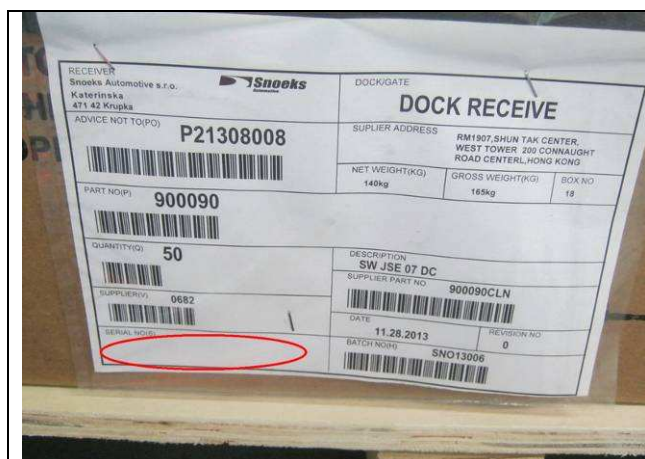
SAP 5.1-the SERIAL NO(S) on the information label was blank

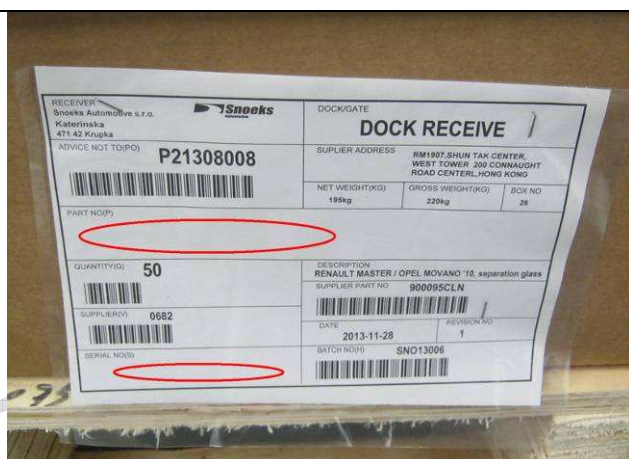
SAP 5.1-the SERIAL NO(S) and PART NO (P) on the information label was blank

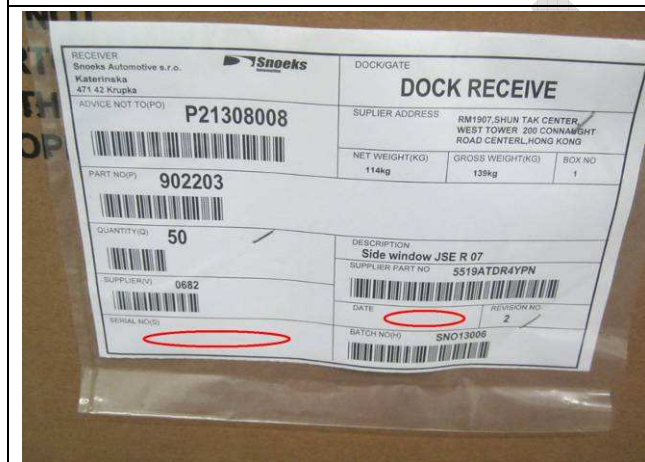
SAP 5.1-the SERIAL NO(S) and DATE on the information label was blank

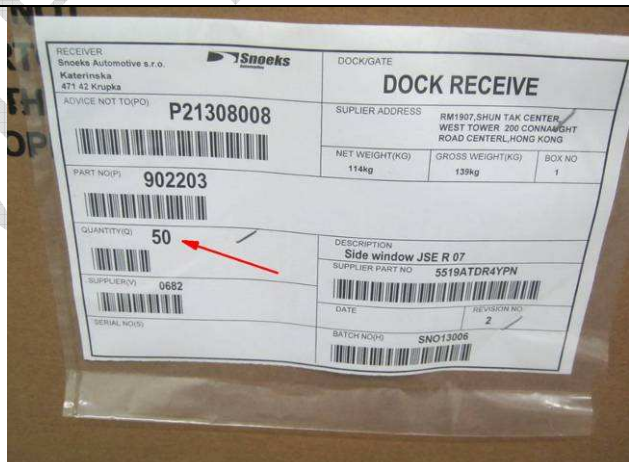
SAP 5.4-the quantity was 50 instead of 20

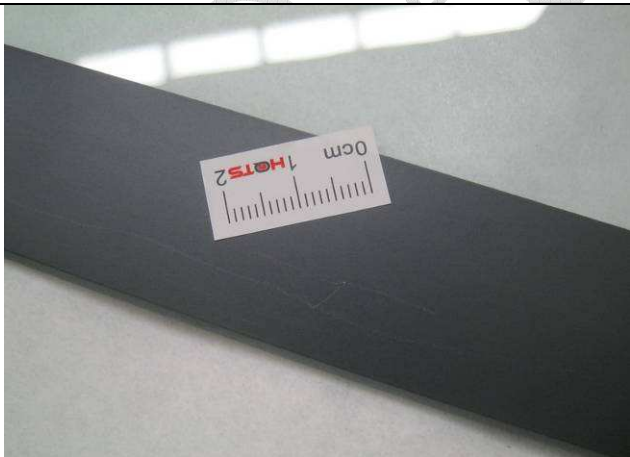
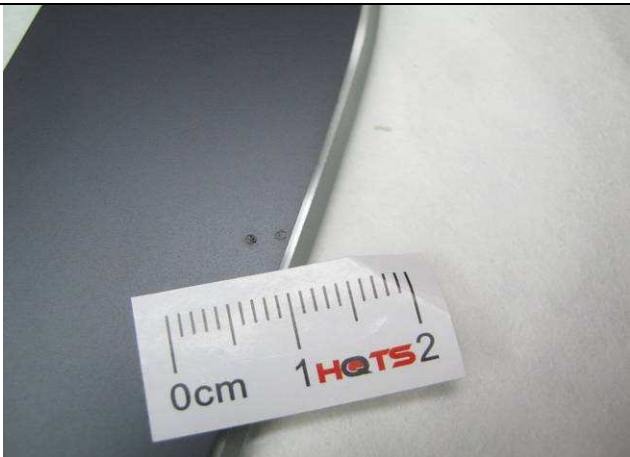
2. Workmanship		Pending		
Defects Description		Critical	Major	Minor
Item#: 900095				
slight scratch on the print		-	-	1
Item#: 900090				
dents on the print		-	-	2
Item#: 900971				
obvious scratch on the print		-	1	-
Total Found:		0	1	3
Allowed:		0	7	10

item 900095-defect-slight scratch on the print-mi	item 900090-defect-dents on the print-mi

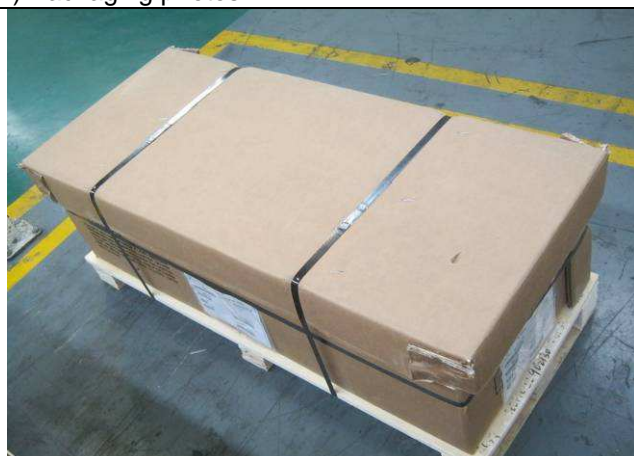
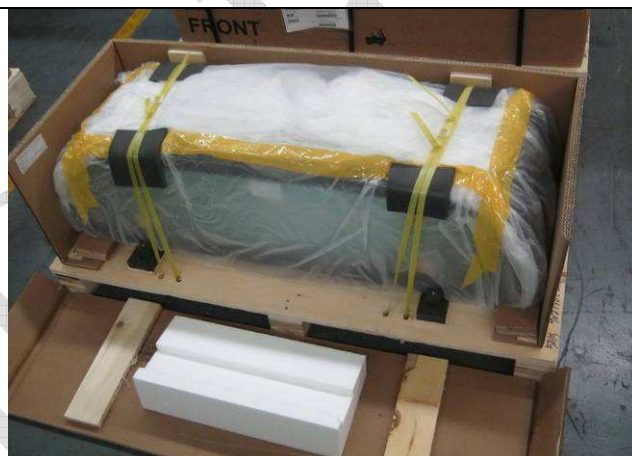
2) Packaging photos

Only item no. 902130 is listed here for your reference. For other items please refer to photos attached.

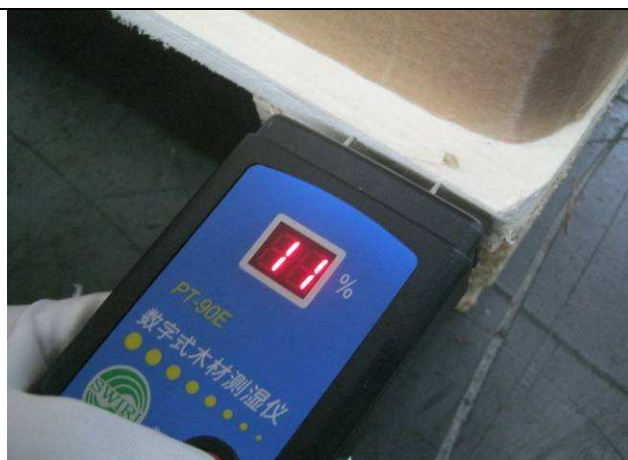
Item No.	Moisture content check	
	Specification	Result
All items	8-18%	11-14%

moisture content check

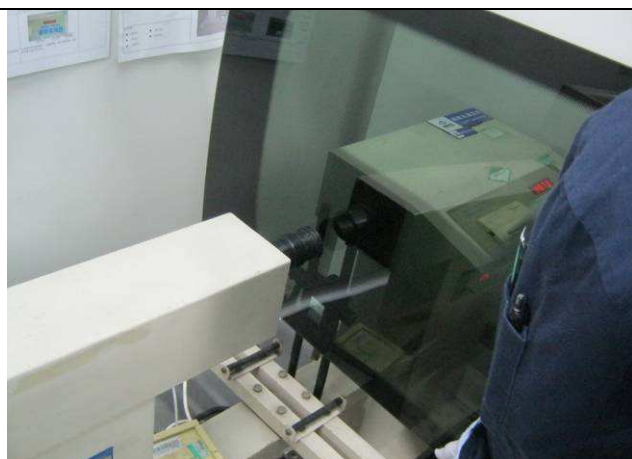
Item No.	Light transmission rate check	
	Specification	Result
902203	16,50% - 20,50%	19.81%
900060	88,20%-91,20%	88.86%
900085	88,20%-91,20%	88.92%
900090	88,20%-91,20%	88.95%
900095	88,20%-91,20%	88.77%
900961	78,40% - 81,40%	81.70%
900971	78,40% - 81,40%	81.93%
902130	88,20%-91,20%	88.85%
902239	78,40% - 81,40%	80.94%

light transmission rate check
