INSPECTION REPORT

Pre-Shipment Inspection

Report No: H-*****

| Product Description | TRAVERTINE MARBLE | | |

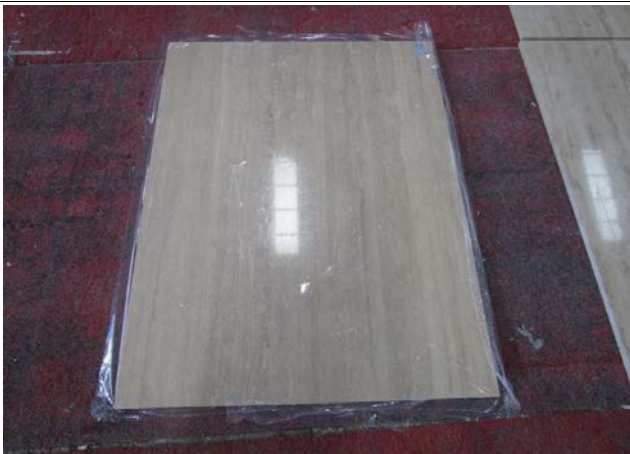
| 5. Shipping Mark & Packaging | | Pending |
|---|--|---|
| 5.2 Packaging photos | | |

Packaging Description:
- 1 piece of product was covered with film.
